Security Council

S/22535
29 April 1991

LETTER DATED 26 APRIL 1991 FROM THE SECRETARY-GENERAL
ADDRESSED TO THE PRESIDENT OF THE SECURITY COUNCIL

REPORT TO THE SECRETARY-GENERAL BY A UNITED NATIONS MISSION, LED BY MR. ABDULRAHIM A. FARAH, FORMER UNDER-SECRETARY-GENERAL, ASSESSING THE SCOPE AND NATURE OF DAMAGE INFLICTED ON KUWAIT'S INFRASTRUCTURE DURING THE IRAQI OCCUPATION OF THE COUNTRY FROM 2 AUGUST 1990 TO 27 FEBRUARY 1991

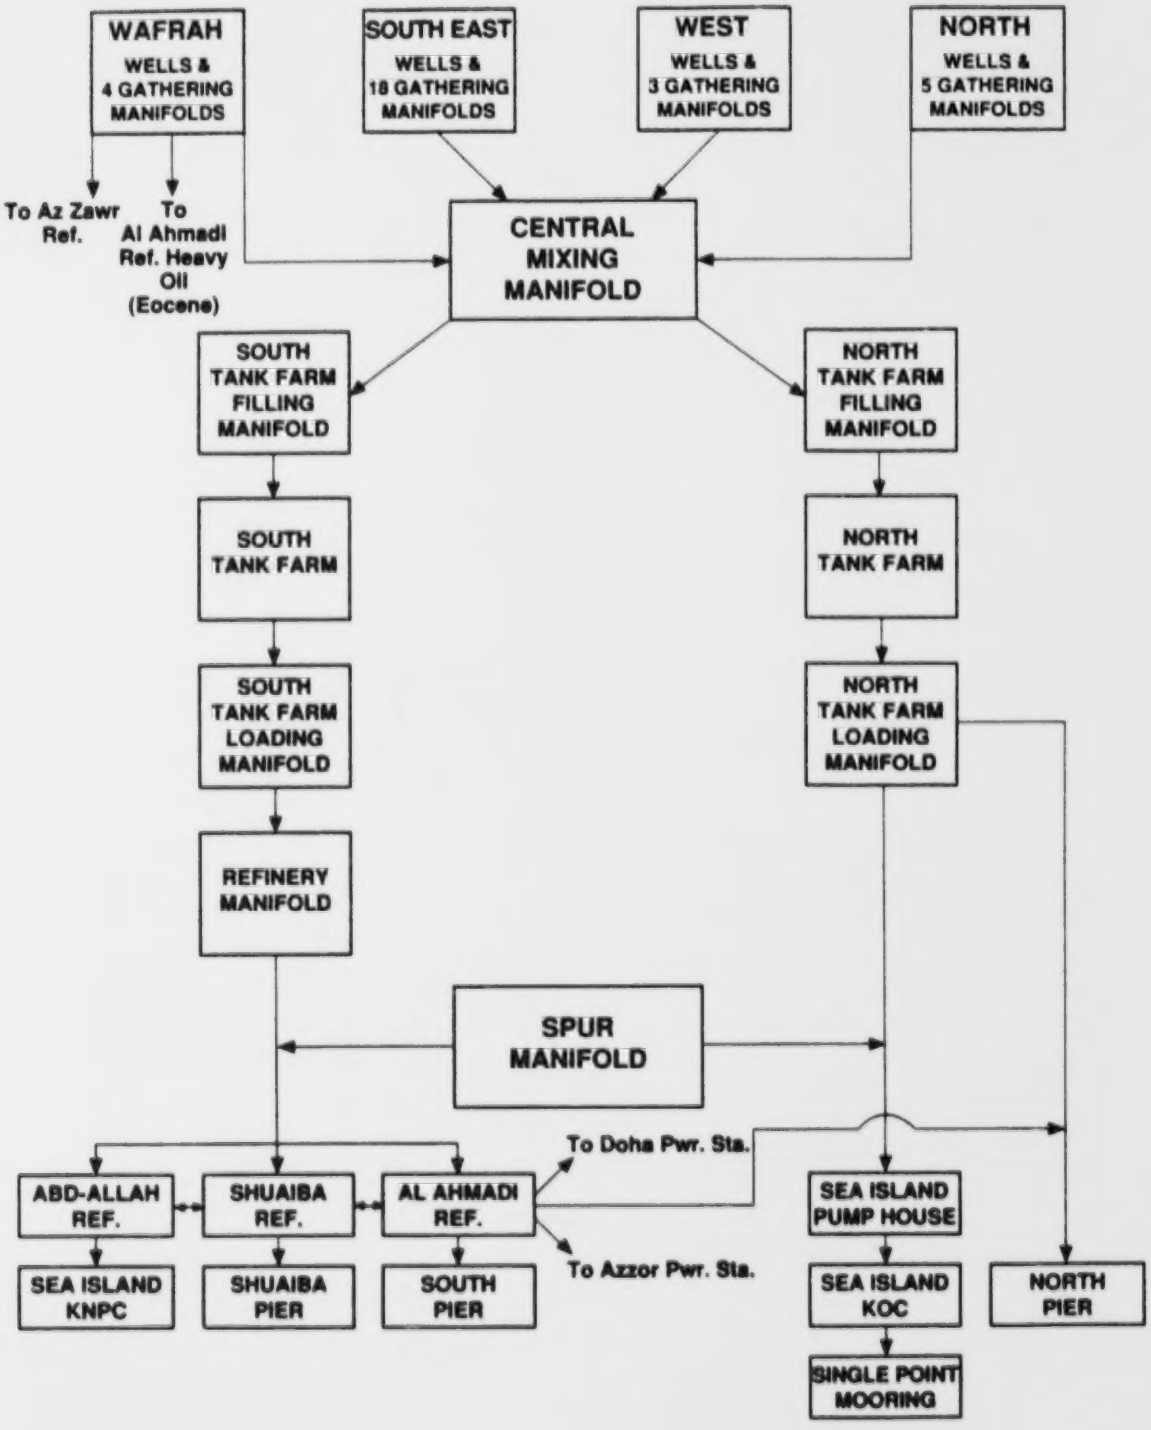
Figure 1

Petroleum Production Network

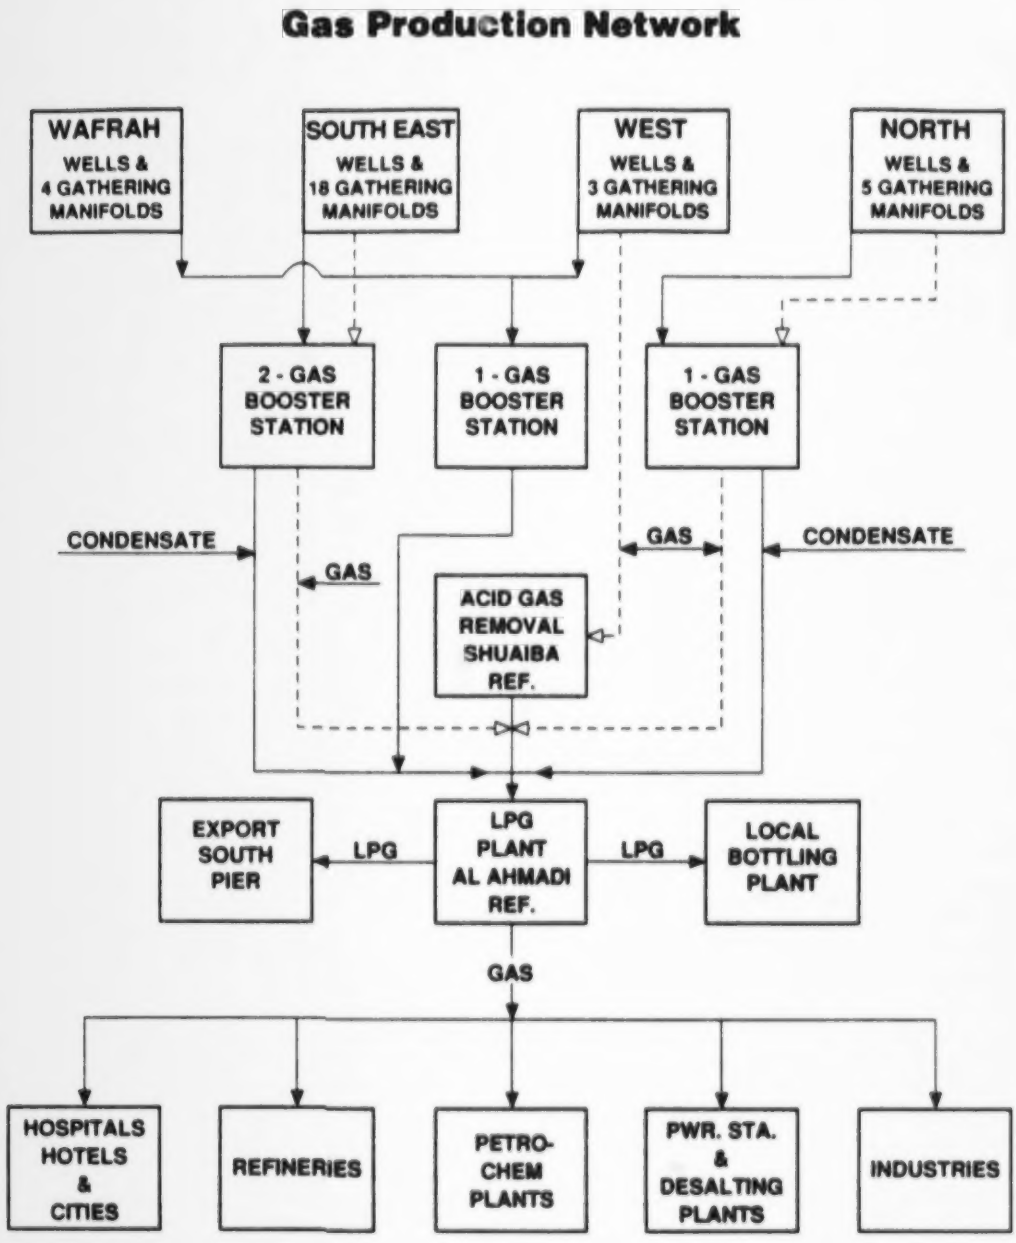
Figure 2

Gas Production Network
WAFRAH
WELLS &
4 GATHERING
MANIFOLDS
SOUTH EAST
WELLS &
18 GATHERING
MANIFOLDS
WEST
WELLS &
3 GATHERING
MANIFOLDS
NORTH
WELLS &
5 GATHERING
MANIFOLDS
2 - GAS
BOOSTER
STATION
1 - GAS
BOOSTER
STATION
1 - GAS
BOOSTER
STATION
CONDENSATE
GAS
GAS
CONDENSATE
ACID GAS
REMOVAL
SHUAIBA
REF.
EXPORT
SOUTH
PIER
LPG
LPG
PLANT
AL AHMADI
REF.
LPG
LOCAL
BOTTLING
PLANT
GAS
HOSPITALS
HOTELS
&
CITIES
REFINERIES
PETRO-
CHEM
PLANTS
PWR. STA.
&
DESALTING
PLANTS
INDUSTRIES

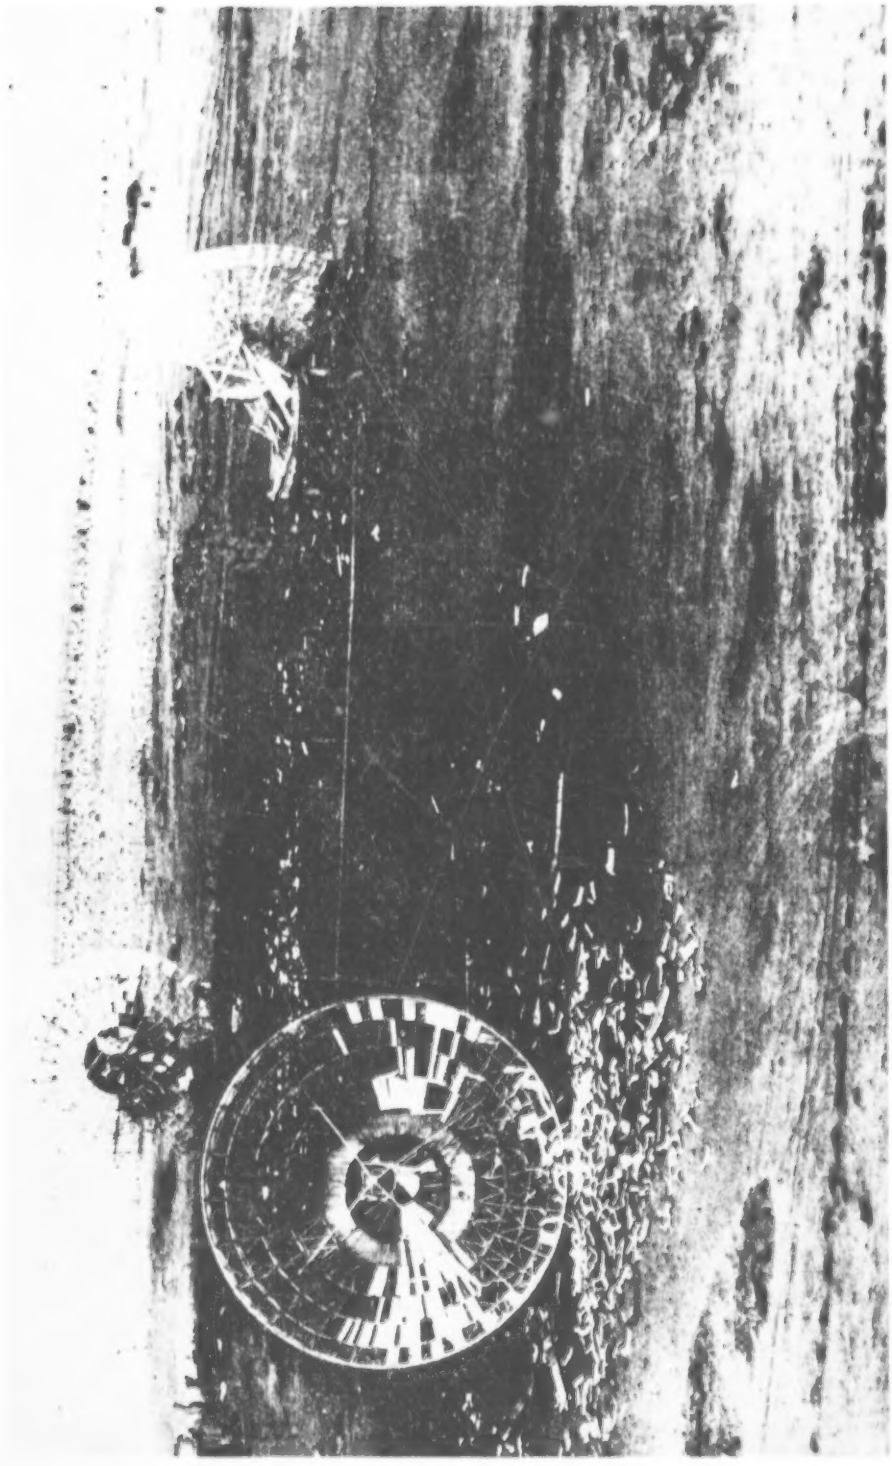
4. Wreckage of the Earth satellite station in northern Kuwait 92

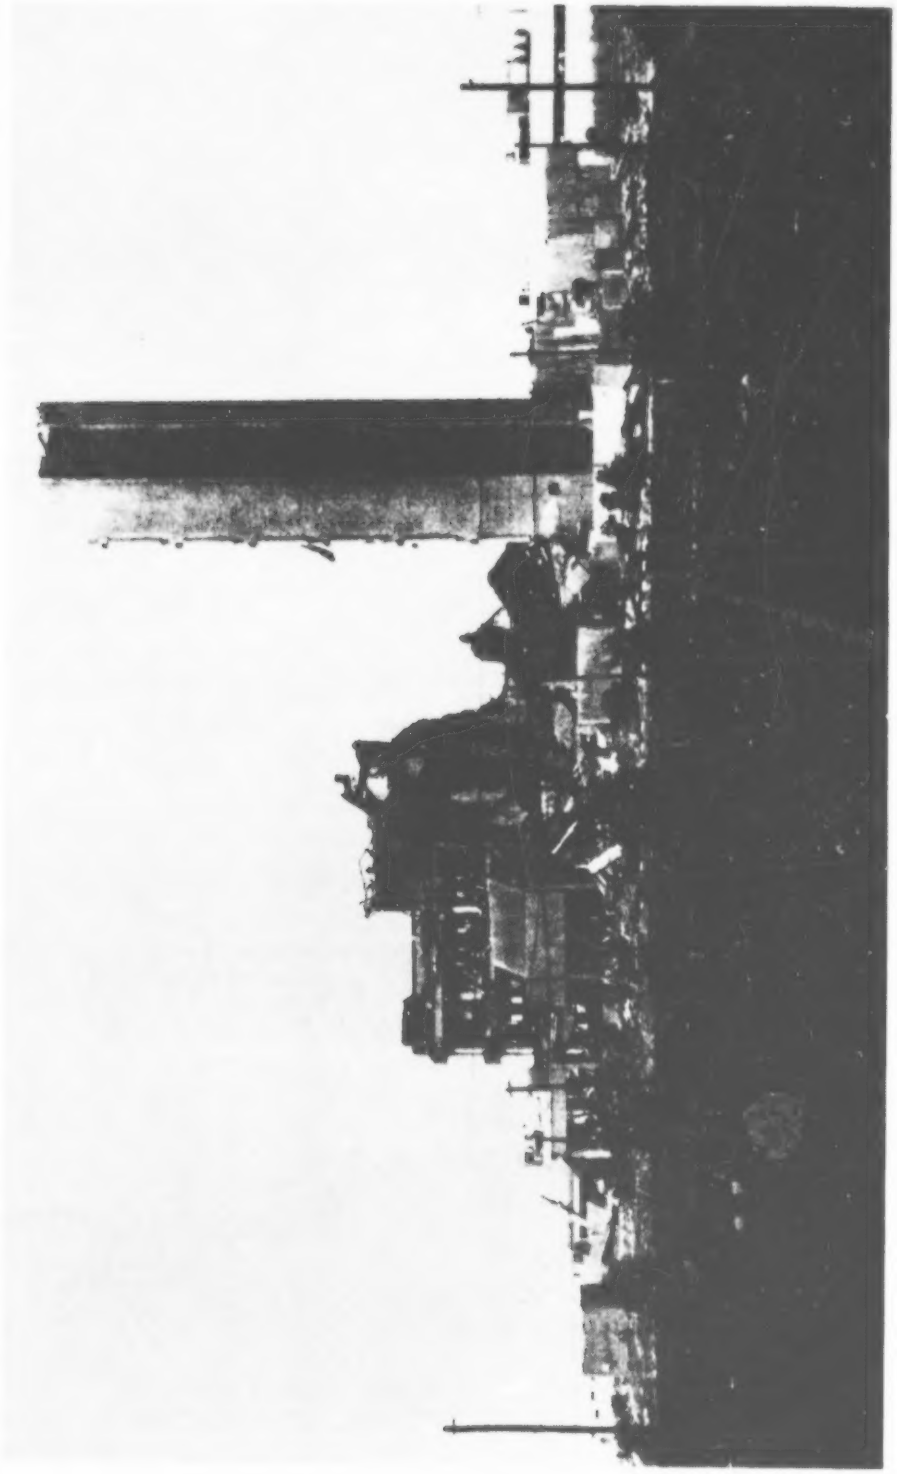
5. South Subahiya Telecommunications Centre totally destroyed by explosives 93

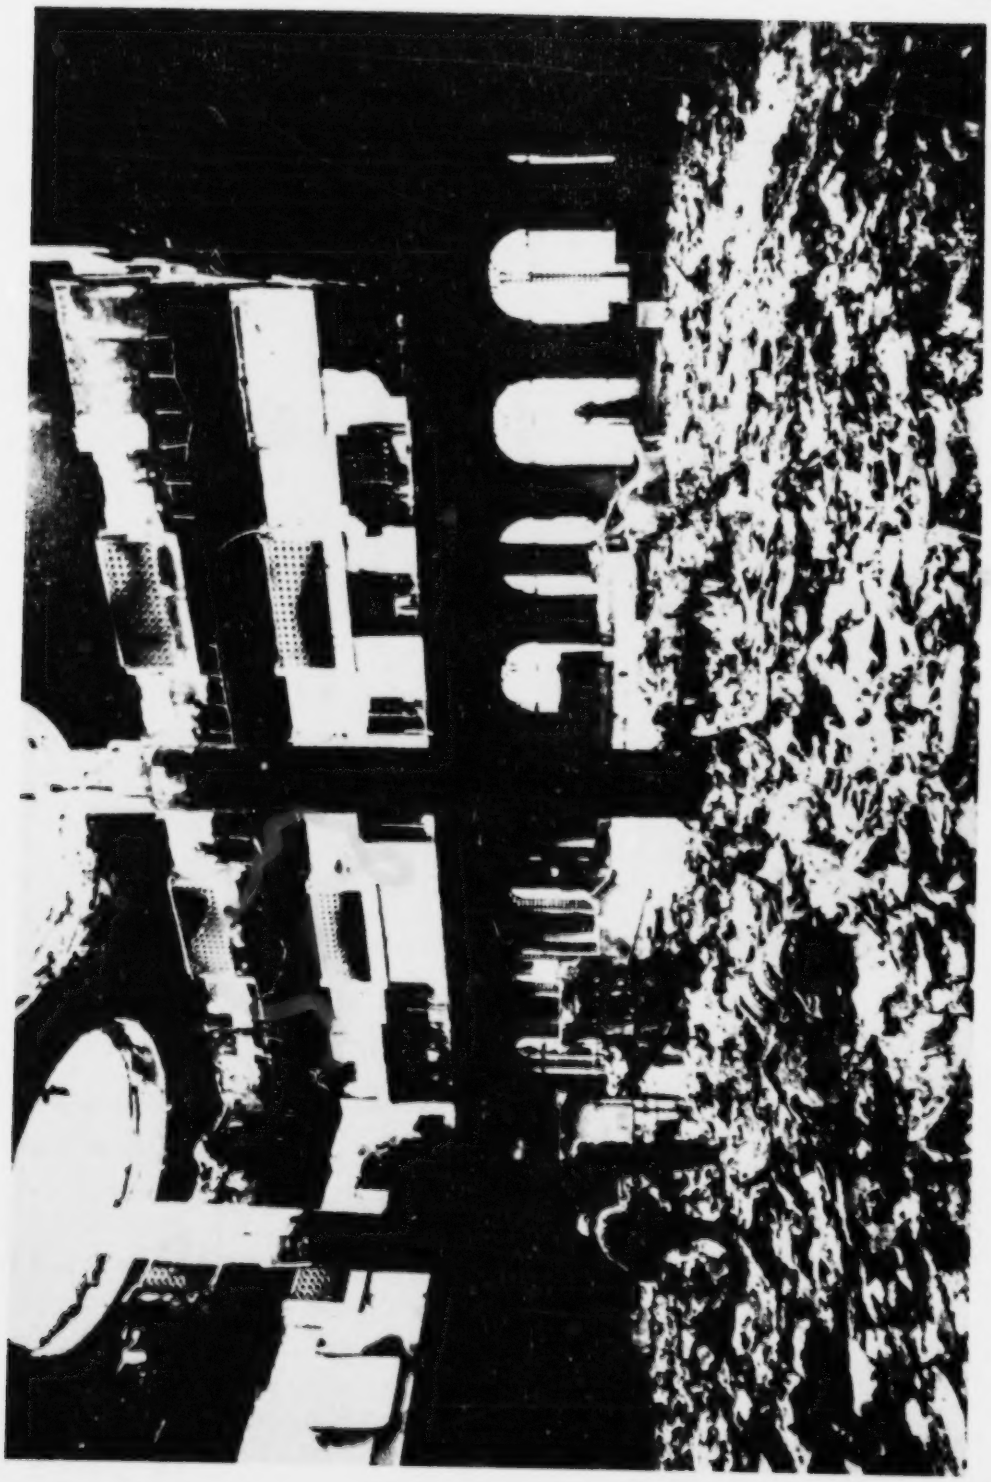
5. The Regency Hotel lobby in Kuwait City. Seven de luxe and first-class hotels were either destroyed or heavily damaged during the last days of the occupation 113

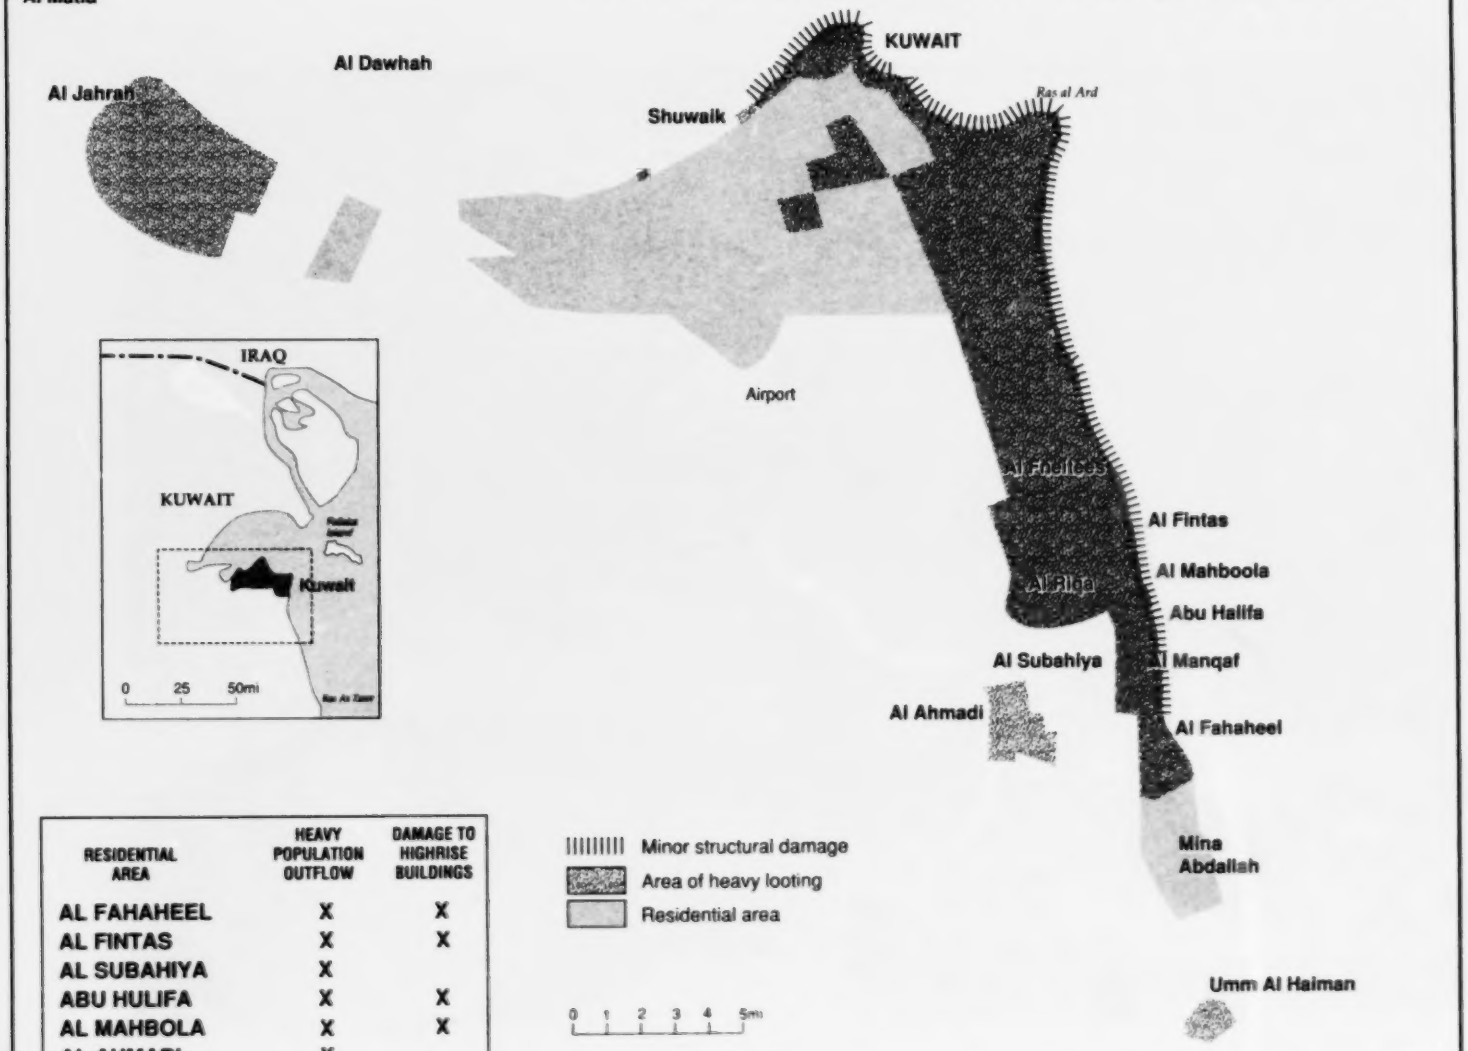
Map 10

CONDITION OF RESIDENTIAL INFRASTRUCTURE

RESIDENTIAL AREA	HEAVY POPULATION OUTFLOW	DAMAGE TO HIGHRISE BUILDINGS
AL FAHAHEEL	X	X
AL FINTAS	X	X
AL SUBAHIYA	X	
ABU HULIFA	X	X
AL MAHBOLA	X	X
AL AHMADI	X	
AL JAHRAH	X

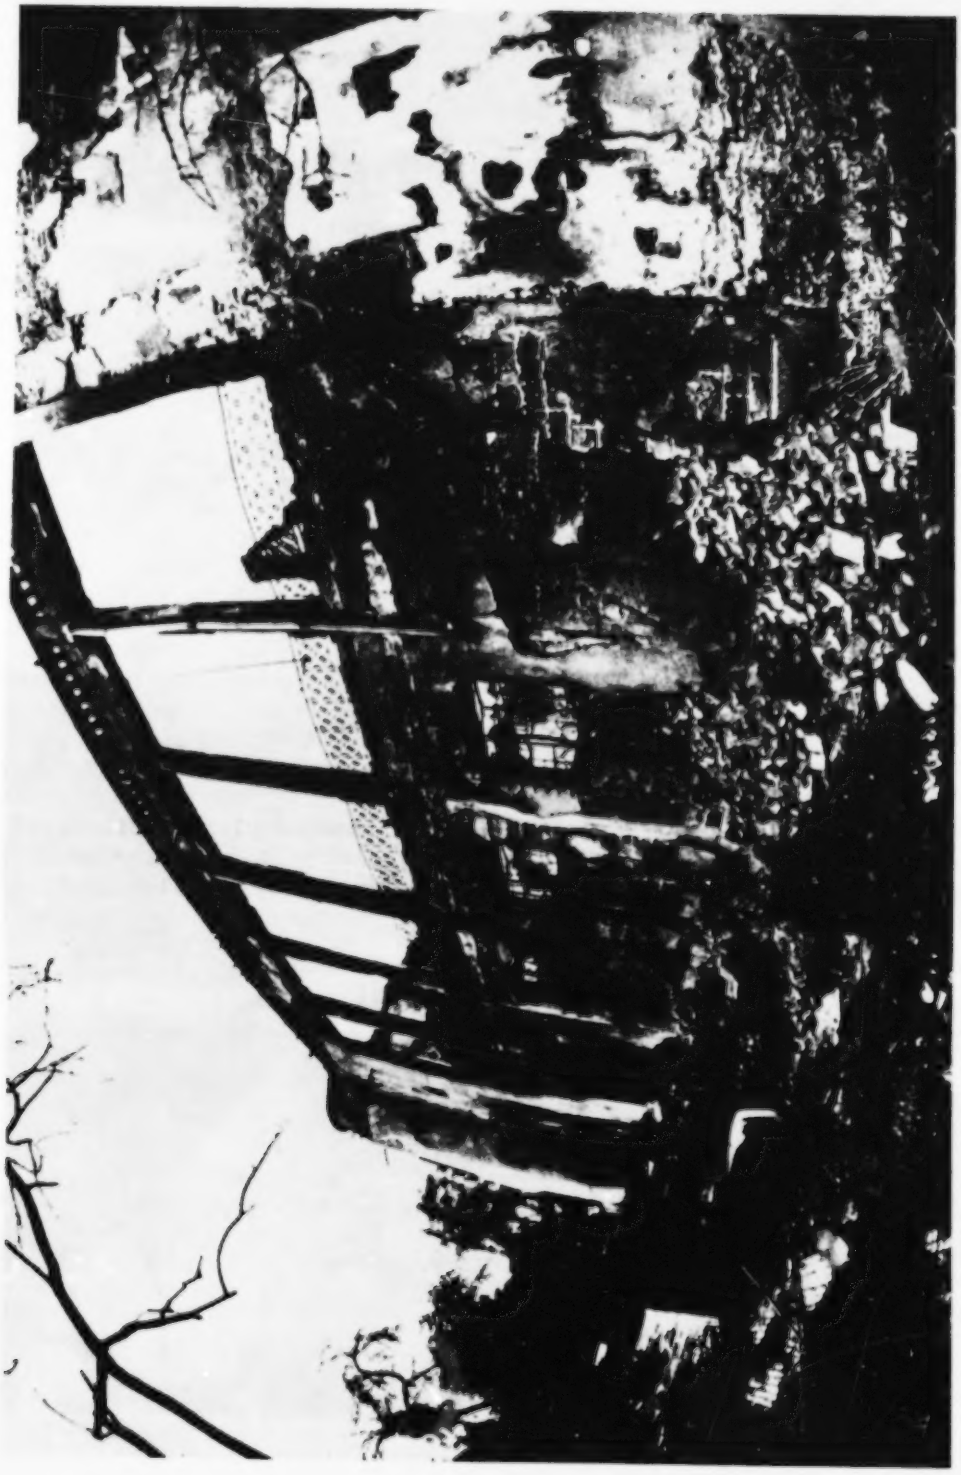
2. A classroom destroyed by the occupation forces 134

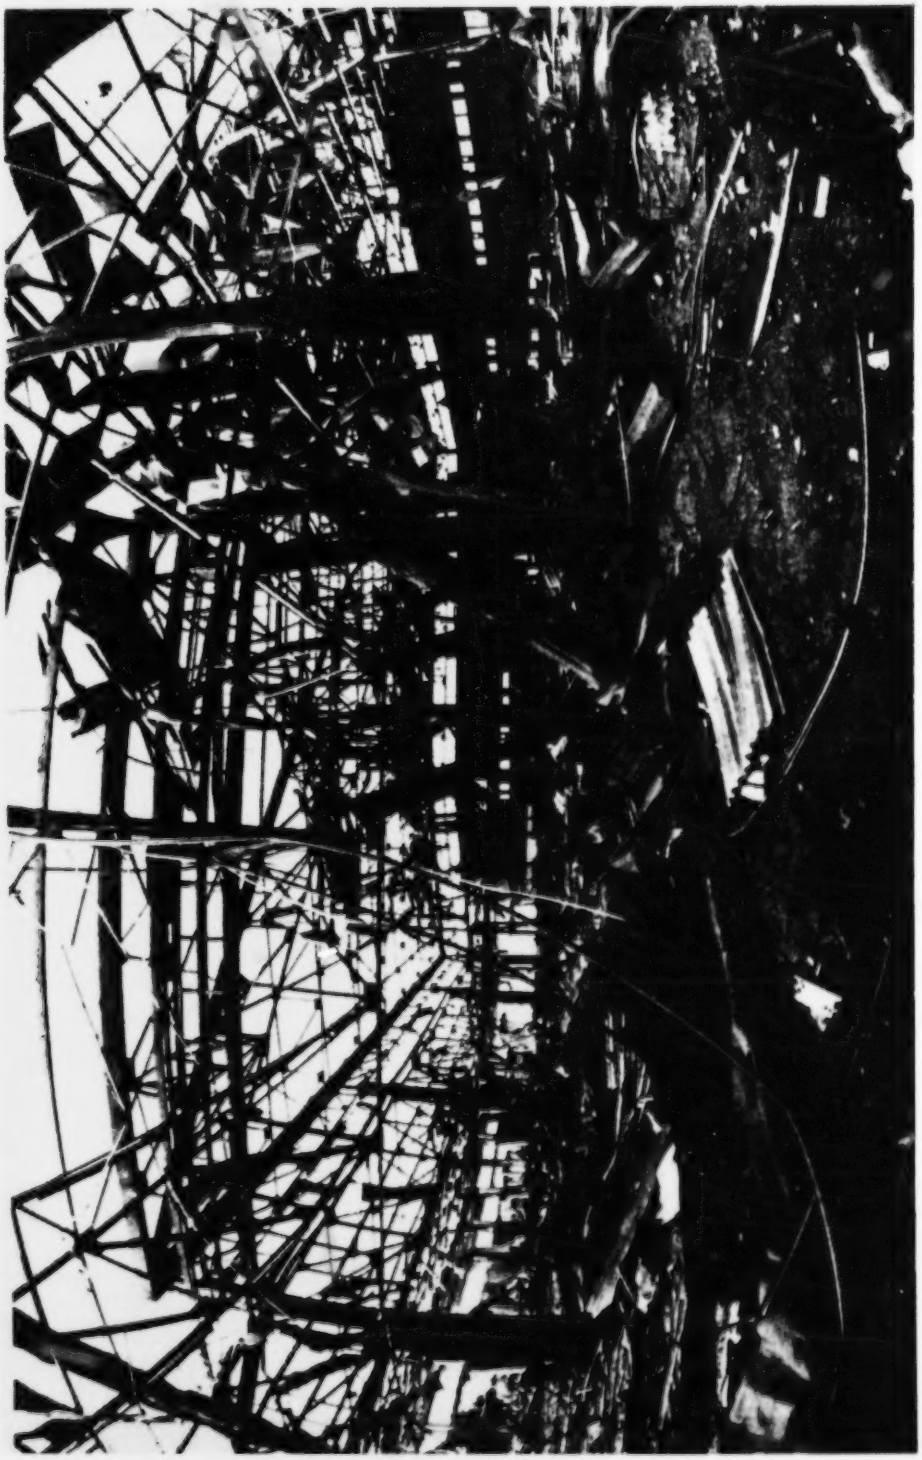
1. One of the three pavilions of the Kuwait International Trade Fair, covering an area of 34,000 square metres, that were totally destroyed 142

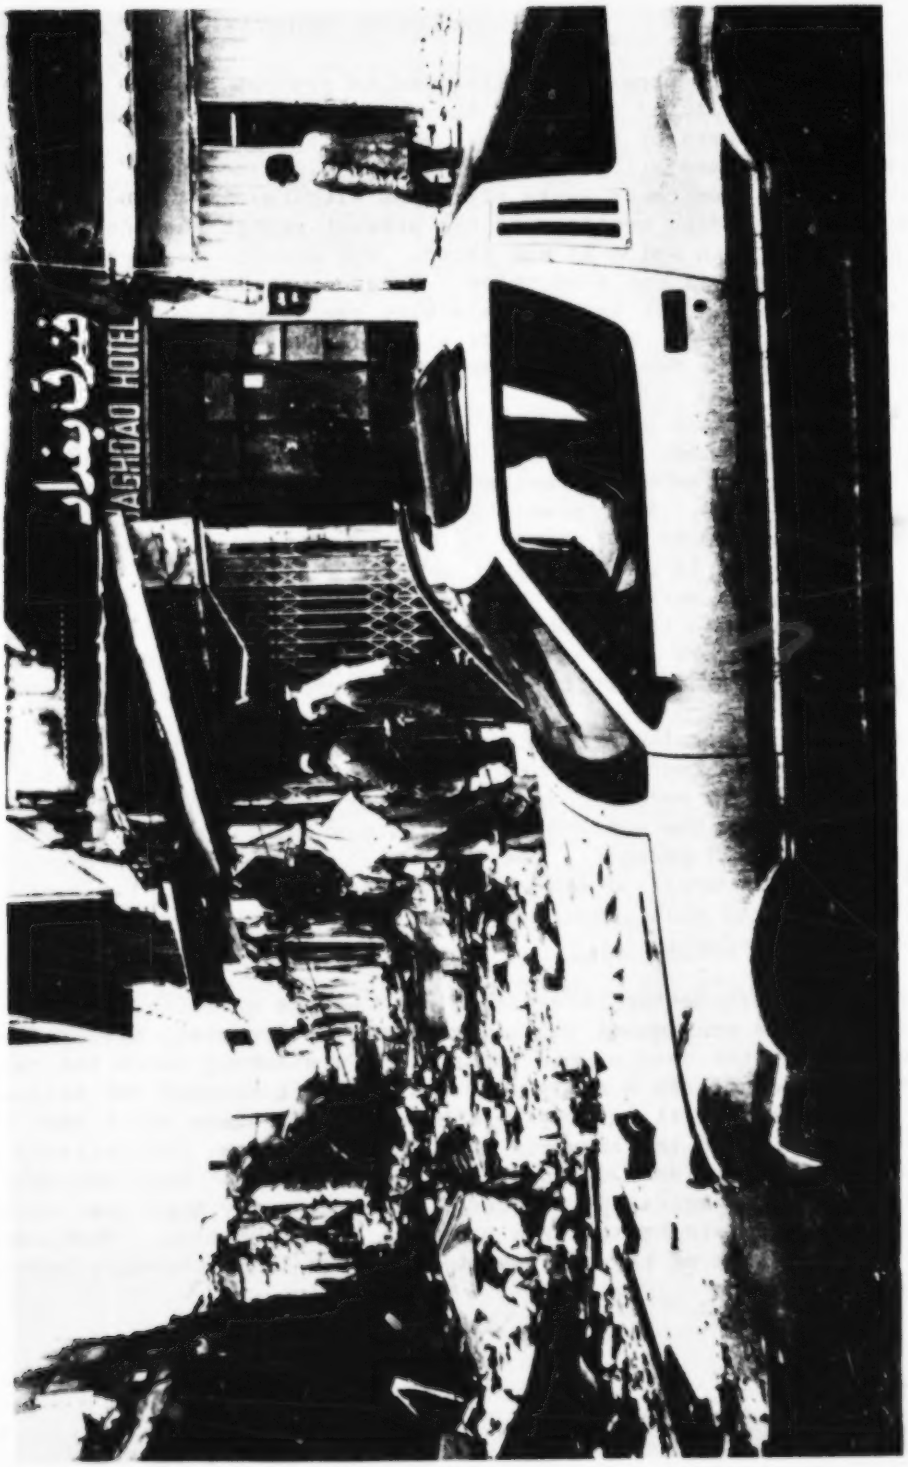
2. Part of the devastated commercial district in Kuwait 143
